# Manhole Inspection Summary

Manhole # S29AA\_028MH

Insp Date: **5/5/09 12:54 PM**

**Location** Address: **556 PRESTON ST**

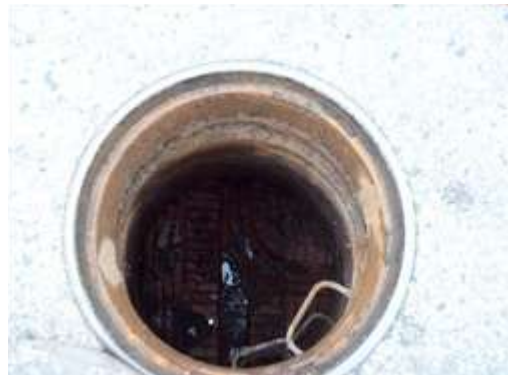
Defect 2

Offset: **2** (in.)

FRAME OFFSET

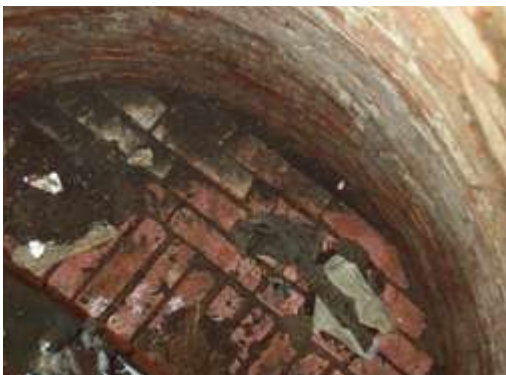
Defect 1

☒ **Evidence Of Surcharge** Depth: **3.7** (ft.) ☐ Active Surcharge Present

EVIDENCE OF SURCHARGE

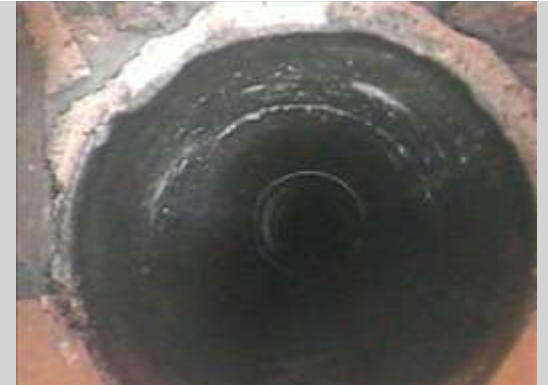
12 O'Clock Outflow

8 in. Circular Gravity Sewer  
Pipe Out @ 12 O'Clock

Pipe Material: **Clay** ☐ Pipe Lined

Invert Depth: **8.80** (ft.) Flow Characteristics: **Slow**

Infiltration: **None** Pipe Seal Cond: **Sound**

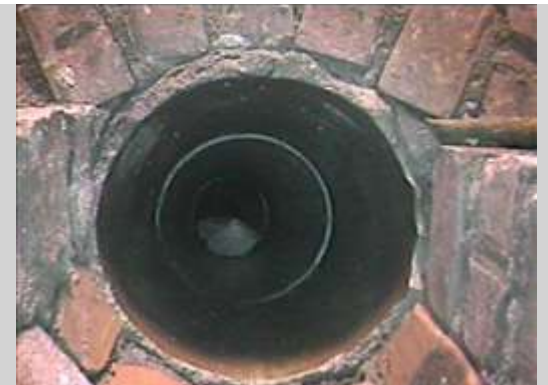
3 O'Clock Inflow

8 in. Circular Gravity Sewer  
Pipe In @ 3 O'Clock

Pipe Material: **Clay** ☐ Pipe Lined

Invert Depth: **8.34** (ft.) Flow Characteristics: **None**

Infiltration: **None** Pipe Seal Cond: **Sound**

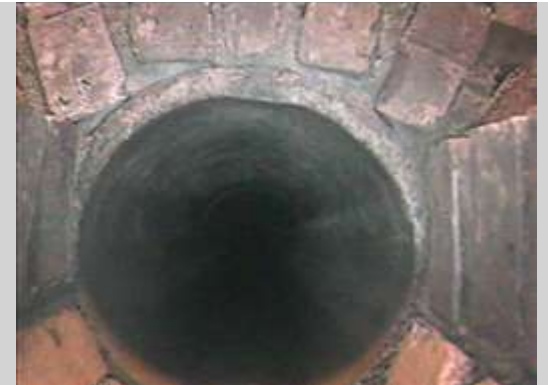
6 O'Clock Inflow

8 in. Circular Gravity Sewer

Pipe In @ 6 O'Clock

Pipe Material: **Clay** ☐ Pipe Lined

Invert Depth: **8.52** (ft.) Flow Characteristics: **Slow**

Infiltration: **None** Pipe Seal Cond: **Sound**
